Mercury Lamp
Drum-Top Crusher
Study

TABLE OF CONTENTS

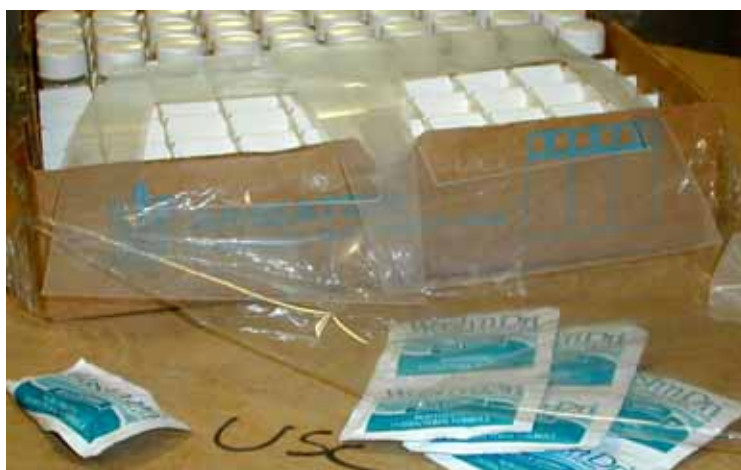
Photograph 3. 8: Wipe Sample Media

Surface wipe samples were collected inside the containment structure on numerous surfaces both before and after lamp crushing, as part of the Mass Balance Study. The wipe samples were collected and analyzed in accordance with N9103 for wipe samples (*refer to Appendix E*). Under this procedure, a 100 square centimeter (cm²) area was wiped using a "Wash N' Dri" towelette (the liquid component of the wipe is 5 to 10 percent ethanol and 80 to 90 percent water), which was placed into a glass vial. Wipe sample supplies were provided by Data Chem (*refer to Photograph 3. 8*).
